BUILDING ANALYSIS REPORT

Property Location: *2204 River Trail Ct
De Pere, WI 54115*

Date of Inspection: *2/15/2021*

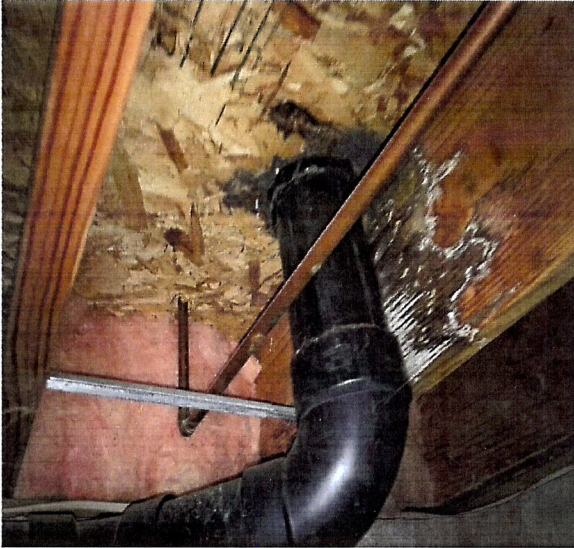
IMG_5788[1].JPG

The master toilet flange shows past leakage stains. The owner stated that the toilet has a new was ring. No active leakage was noted.

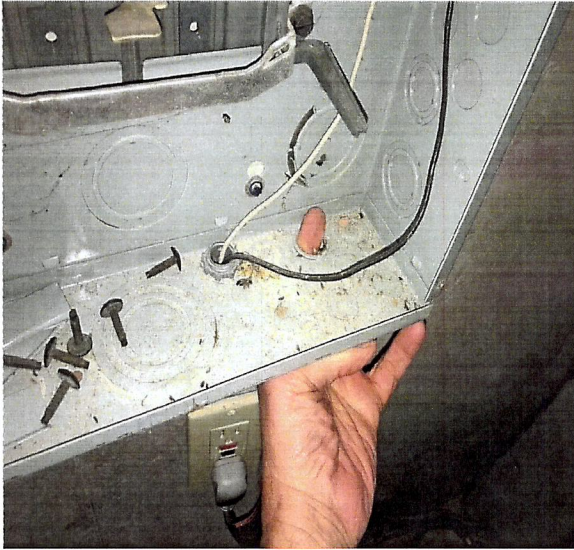
IMG_5786[1].JPG

One open knock out hole was noted at the base of the panel.
This open knockout hole needs to be plugged.
