BUILDING ANALYSIS REPORT

Client: *Jeff and Tammy Van Beaver*

Property Location: *934 S Clay St
Green Bay, WI*

Date of Inspection: *10/16/2023*

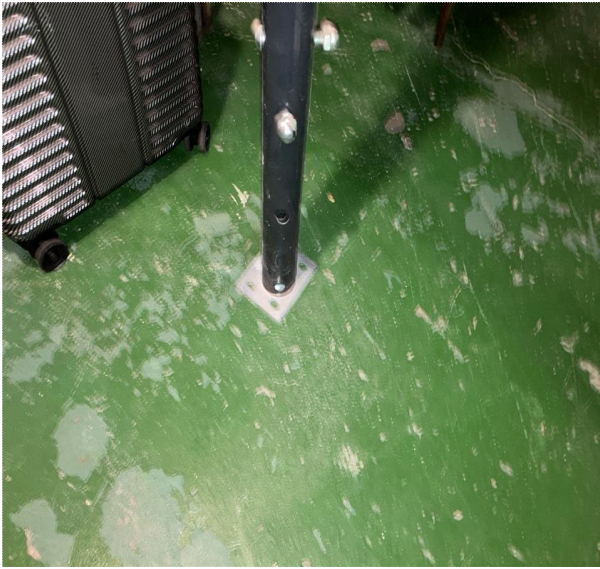
IMG_9476[1].JPG

The metal bearing posts should be secured to the basement slab with proper fasteners.

Item	Estimated Price Range
<i>Budget for a new furnace. (28 years old) Replace the rotten trim boards on the back deck. Secure the metal bearing posts to the basement slab and main beam.</i>

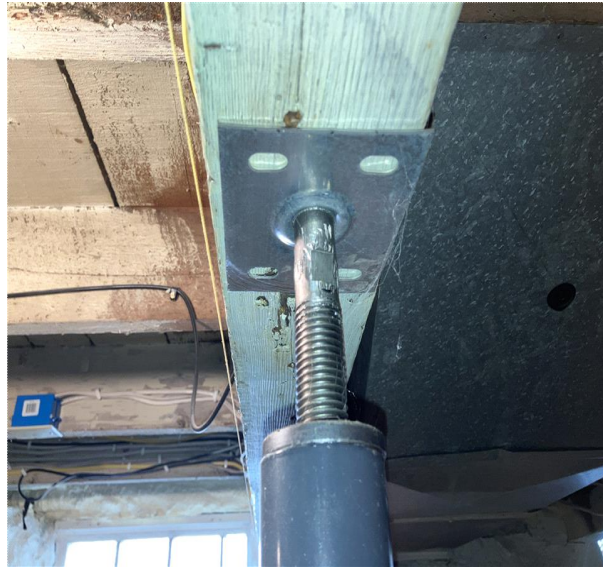
IMG_9477[1].JPG

The metal bearing posts should be secured to the main beam with proper fasteners.

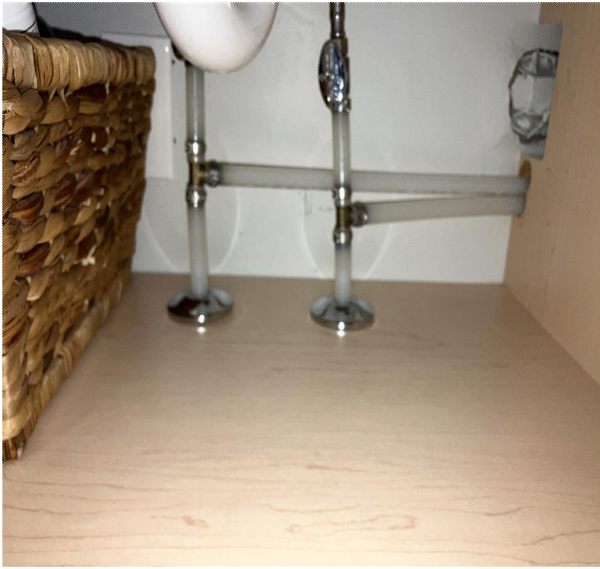
IMG_9475[1].JPG

The plumbing water lines at the master bathroom vanity are split. Each vanity faucet should have its own supply line instead of being split. No signs of pressure problems were

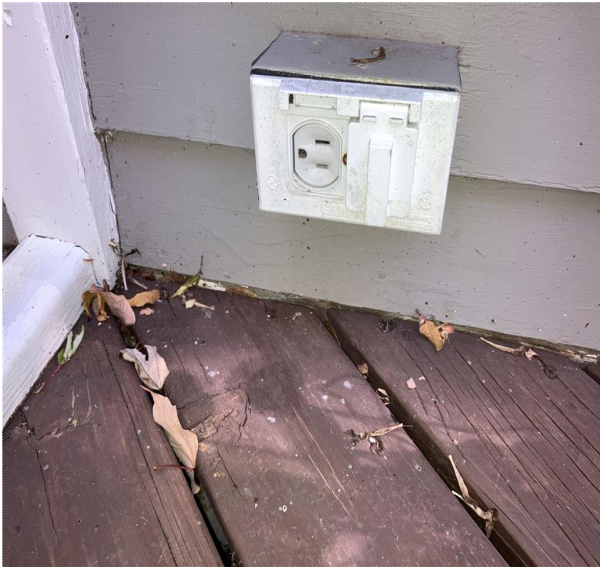
IMG_9480[1].JPG

The back outlet is missing a weather tight cover. One should be added.

- 1. Garage door opener: The garage door safety eyes are mounted too high. The eyes should be mounted no higher than 6" off the floor for safety.*
- 2. Electrical: There was one exterior outlet at the back deck which is missing a weather tight cover. A weather tight cover should be added to this outlet.*

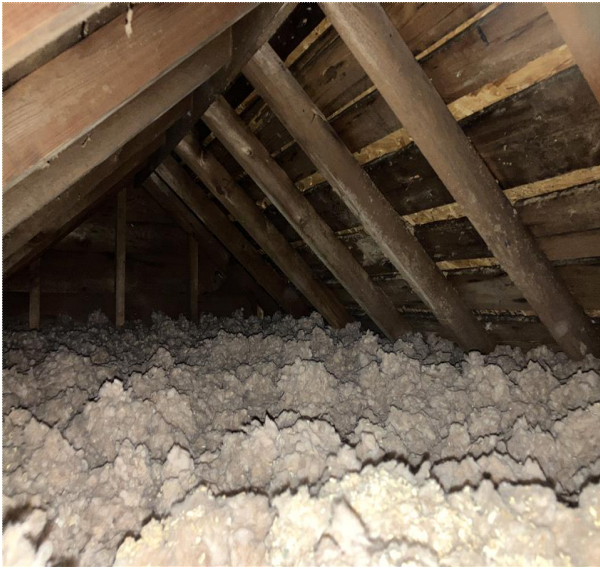
IMG_9484[1].JPG

The attic appears to be well insulated and well ventilated. No moisture stains were noted on the underside of the roof.

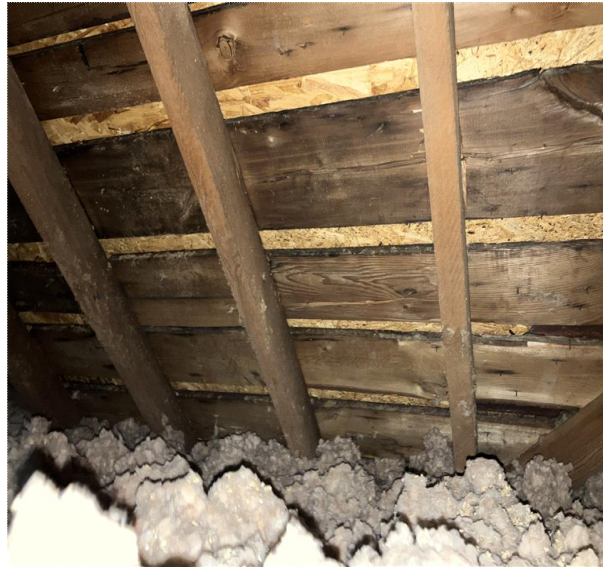
IMG_9485[1].JPG

Parts of the roof have been properly resheathed with OSB sheathing.

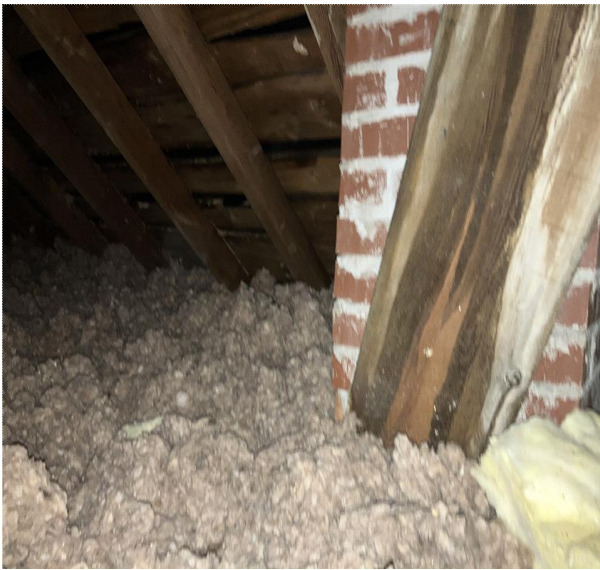
IMG_9486[1].JPG

The attic appears to be well ventilated and well insulated.

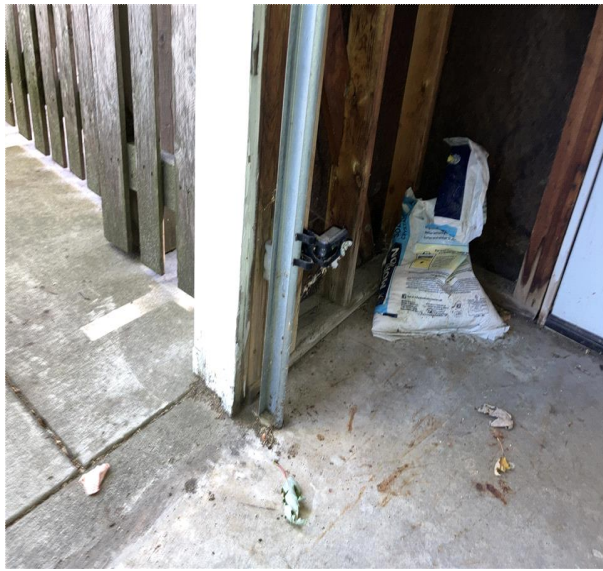
IMG_9478[1].JPG

The safety eyes for the garage door opener should be installed within 6" of the garage floor.

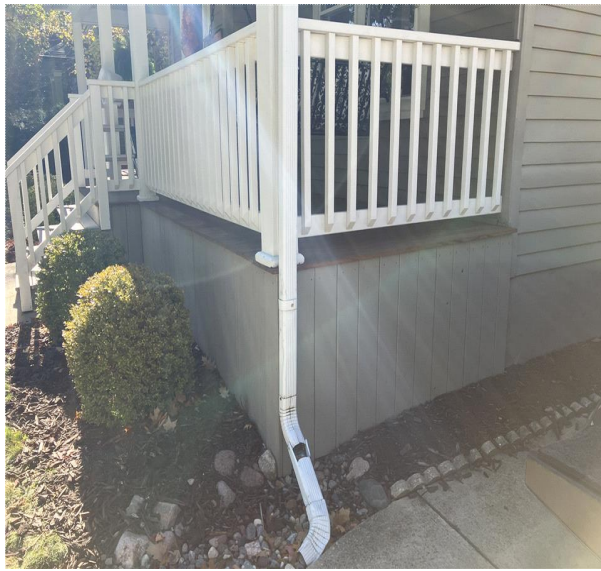
IMG_9483[1].JPG

The front porch appears to have been rebuilt. There was no access doors to inspect the underside of the porch.

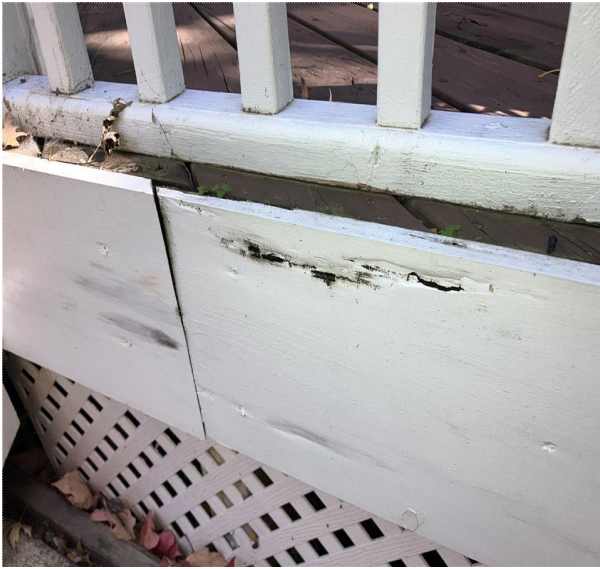
IMG_9479[1].JPG

There was some wood rot noted at the trim board at the back deck.

PATIO, TERRACE	<input type="checkbox"/> Concrete <input type="checkbox"/> Brick <input type="checkbox"/> Flagstone	<input type="checkbox"/> Satisfactory <input checked="" type="checkbox"/> N/A
STEPS TO BUILDING	Landing: <input type="checkbox"/> Concrete/Masonry <input checked="" type="checkbox"/> Wood Steps: <input type="checkbox"/> Concrete/Masonry <input checked="" type="checkbox"/> Wood <input type="checkbox"/> Metal Handrails: <input checked="" type="checkbox"/> Wood <input type="checkbox"/> Metal <input type="checkbox"/>	<input checked="" type="checkbox"/> Satisfactory <input type="checkbox"/> N/A
OUTBUILDING	<input type="checkbox"/> Not inspected	
Remarks	<i>The back deck trim shows some rot. This rotten trim should be replaced.</i>

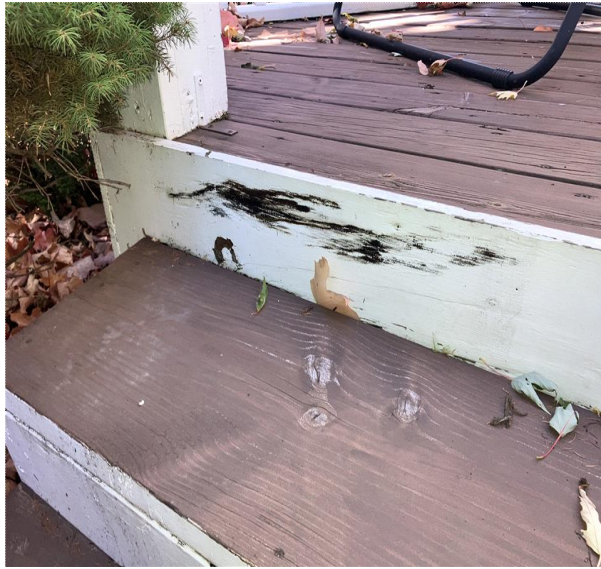
IMG_9481[1].JPG

Some wood rot was noted at the back deck trim boards.

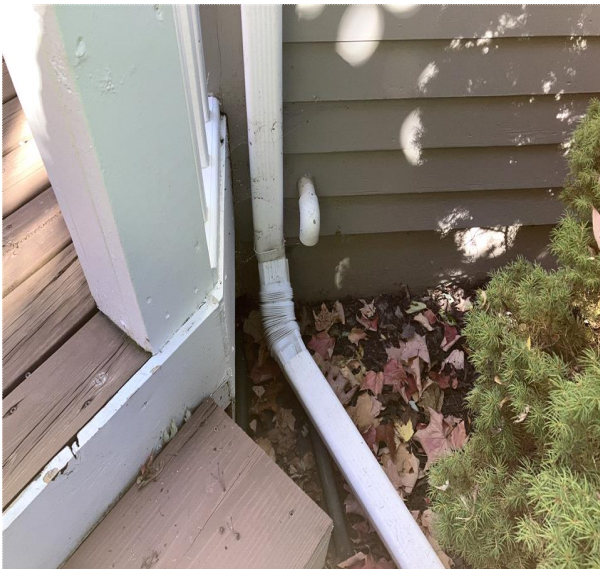
IMG_9482[1].JPG

The sump line should be extended away from the foundation. The sump pump pit was dry and the pump does not appear to run very often, although does function.
