BUILDING ANALYSIS REPORT

Property Location: *2137 Lucille Ct.
Suamico, WI*

Date of Inspection: *3/11/2024*

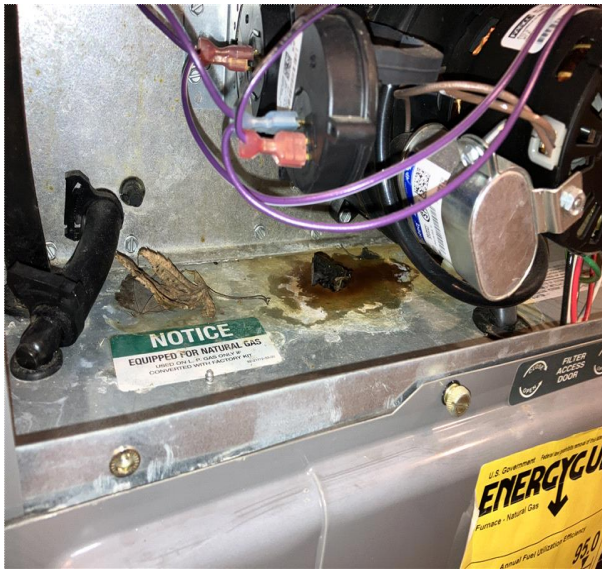
IMG_0824[1].JPG

The furnace was dripping condensate at the draft blower.
This leak needs repair.

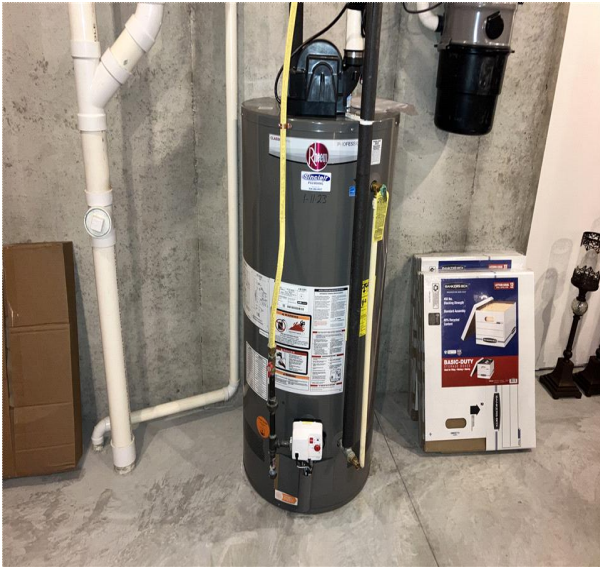
IMG_0825[1].JPG

The water heater has been replaced in the past year.

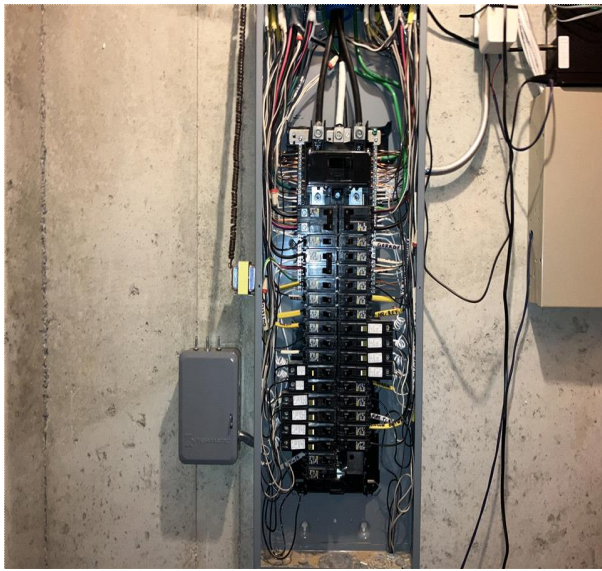
IMG_0826[1].JPG

This is a photo of the main electrical panel. The breaker for the exterior outlet at the back of the lot is turned off. The service is properly grounded and bonded.

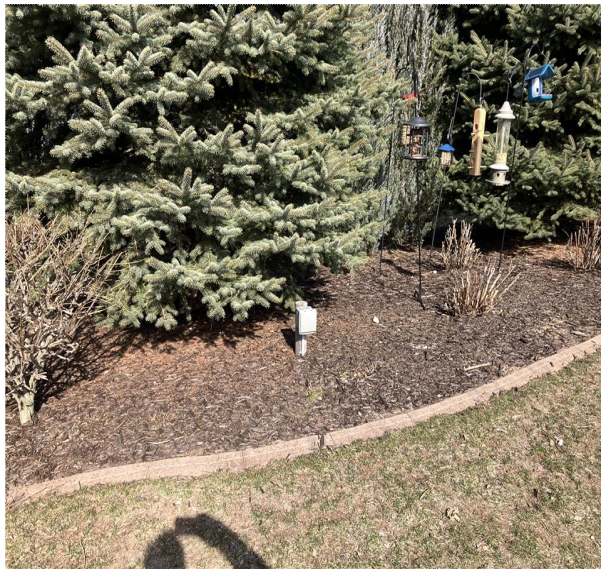
IMG_0834[1].JPG

The yard outlet is turned off in the main service panel.

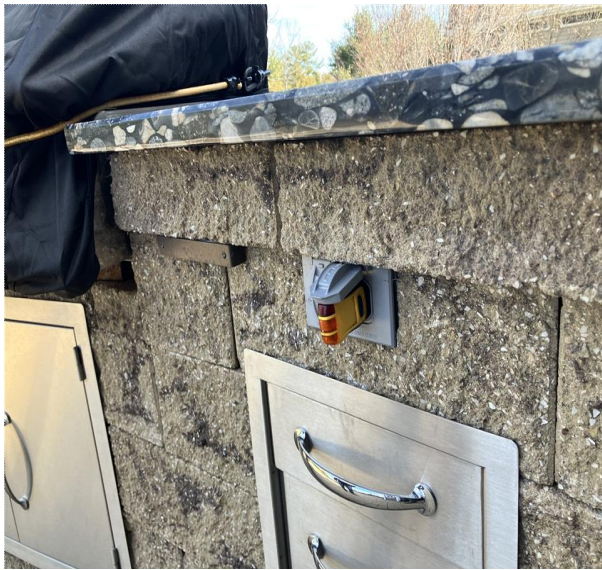
IMG_0837[1].JPG

The outlets at the outdoor grill are missing GFI protection. GFI protected outlets should be added to the outdoor grill outlets.

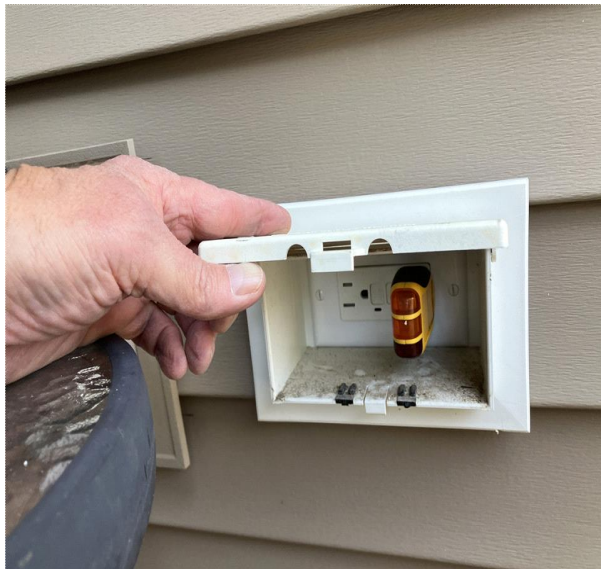
IMG_0838[1].JPG

There were 2 outlets at the back of the home which do not have power. Further evaluation and correction is advised.

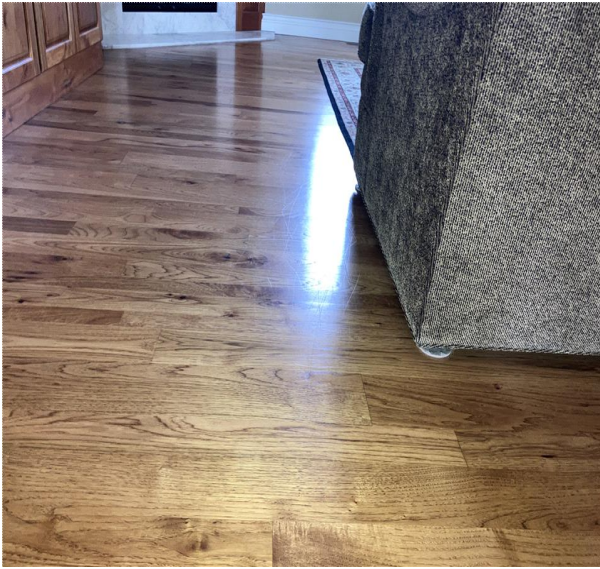
IMG_0827[1].JPG

The hardwood floors show some scratches.

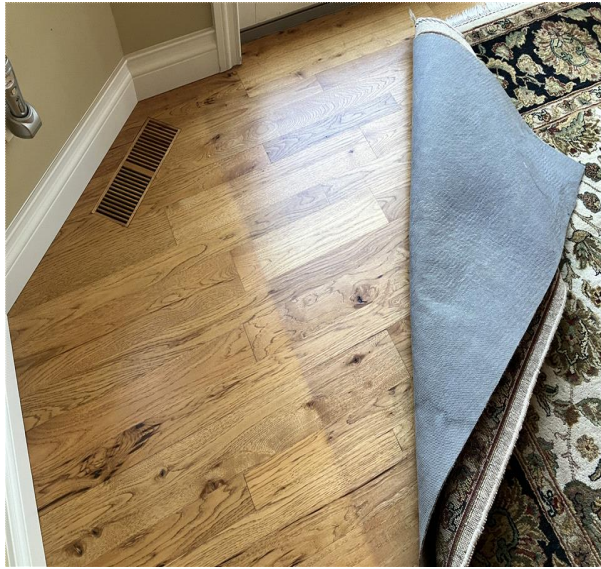
IMG_0828[1].JPG

The hardwood floor in front of the patio door show some discoloration from the sunlight. You may need to refinish the hardwood floors.

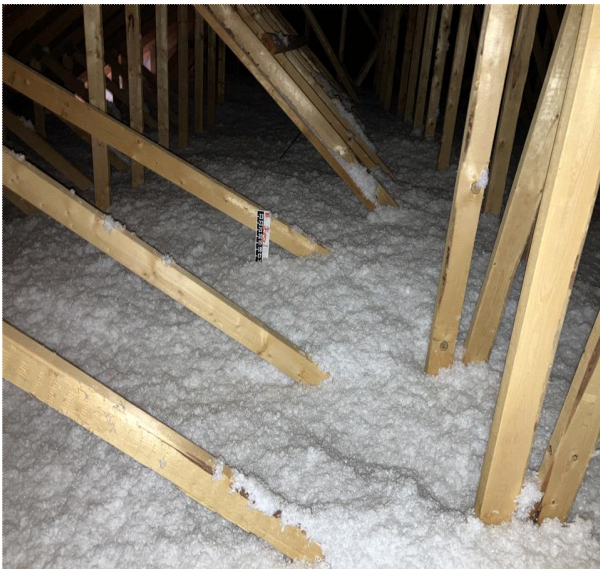
IMG_0829[1].JPG

The attic appears to be well insulated and well ventilated.

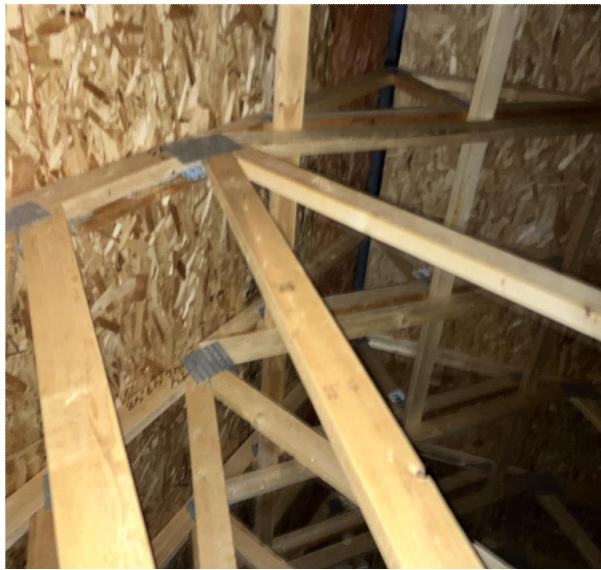
IMG_0830[1].JPG

No signs of any moisture problems were noted in the attic. The ridge vent appears to be properly cut.

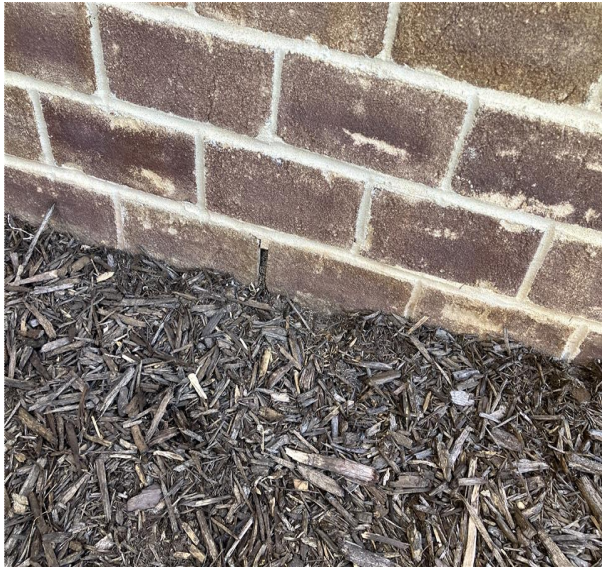
IMG_0831[1].JPG

The brick exterior shows proper weep holes.

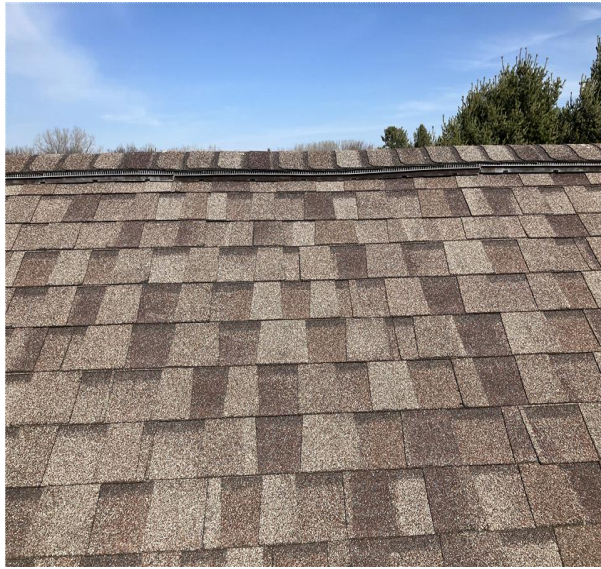
IMG_0832[1].JPG

The roof shingles appear to be in satisfactory condition for their age.

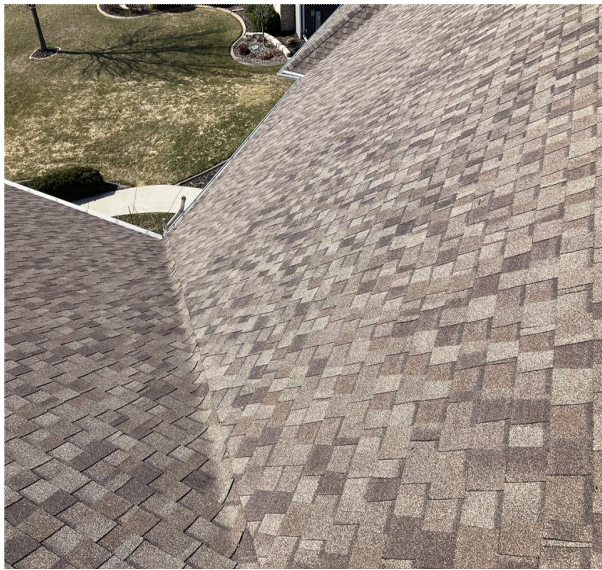
IMG_0833[1].JPG

The roof shingles appear to be in satisfactory condition.

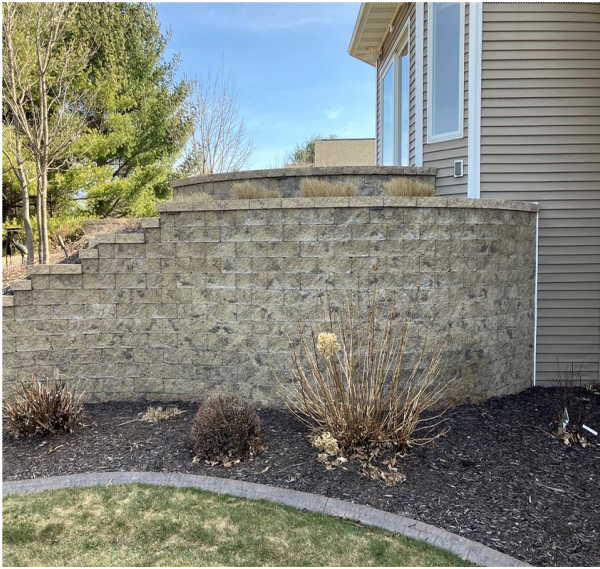
IMG_0835[1].JPG

The block retaining wall appears to be in sound and stable condition.

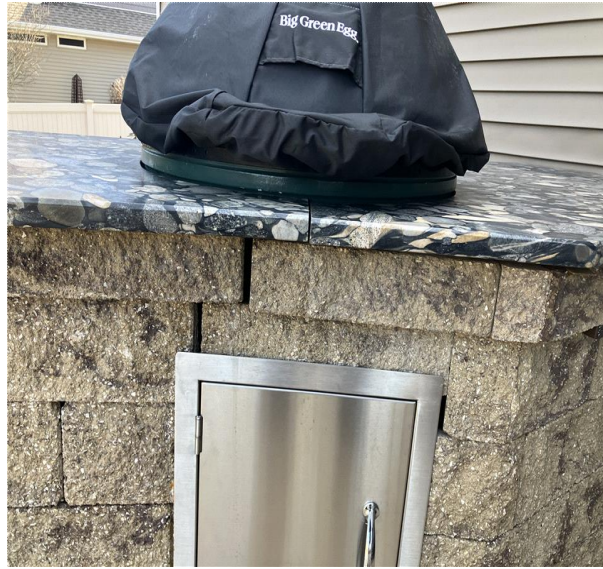
IMG_0839[1].JPG

Some block movement was noted at the outdoor grill.
